## AGENDA ~ Revised

Fort Smith Board of Directors
STUDY SESSION
October 28, 2025 ~ 6:00 p.m.
Blue Lion
101 North 2nd Street
Fort Smith, Arkansas

**SUBJECT:** Five Year Capital Improvement Plan (2026-2030)

Streets, Bridges and Associated Drainage Sales Tax Funds

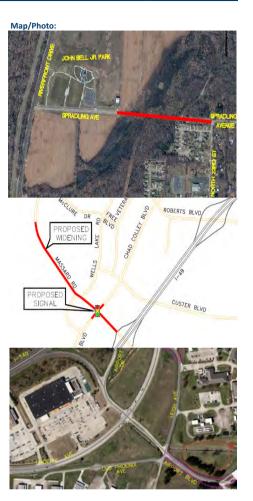
#### Massard Road widening to I-49

Based on commentary from the Board, the start of the construction phase of this project has been pushed to 2029 with an expected completion sometime in 2030. It should be noted that ArDOT estimates that I-49 Segment from Hwy 71 to I-40 will be completed in early 2029.

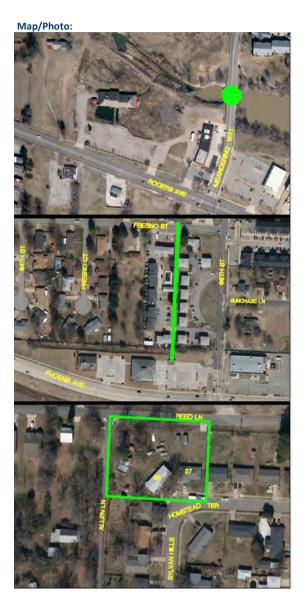
These Neighborhood Drainage Improvement projects consist of repair and rehabilitation of drainage ways, including replacement of existing storm drainage systems and structures to help prevent or reduce flooding. This work also includes efforts to stabilize and armor existing stream banks. Design and construction of the improvements from the 2016 - 2025 CIP cycles will continue.

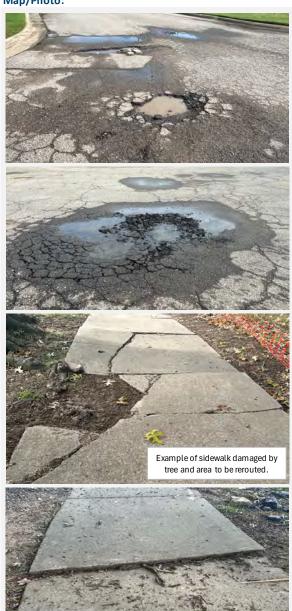
Example of raised section of sidewalk.

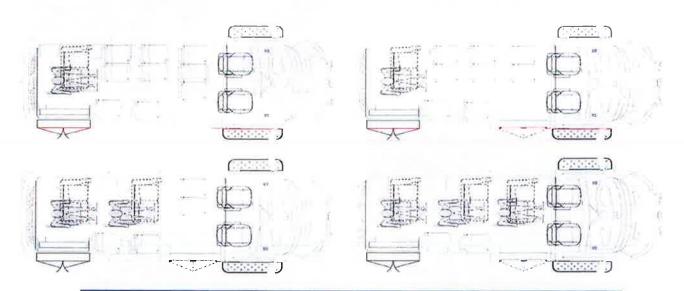
#### **MULTIPLE CONFIGURATIONS**

MobilityTRANS offers a variety of seating configurations to customize the Ford Transit to meet your transportation needs.
